**RE: Administrative Order on Consent Submittals
Waimanalo Gulch Sanitary Landfill**

**RE: Waimanalo Gulch Landfill
Work Plan for Evaluating Hydraulic Head Below Liner System**

**Subject: Work Plan for Sedimentation Basin Restoration- Waimanalo Gulch
Sanitary Landfill, Ewa Beach, Oahu, HI (Draft)**

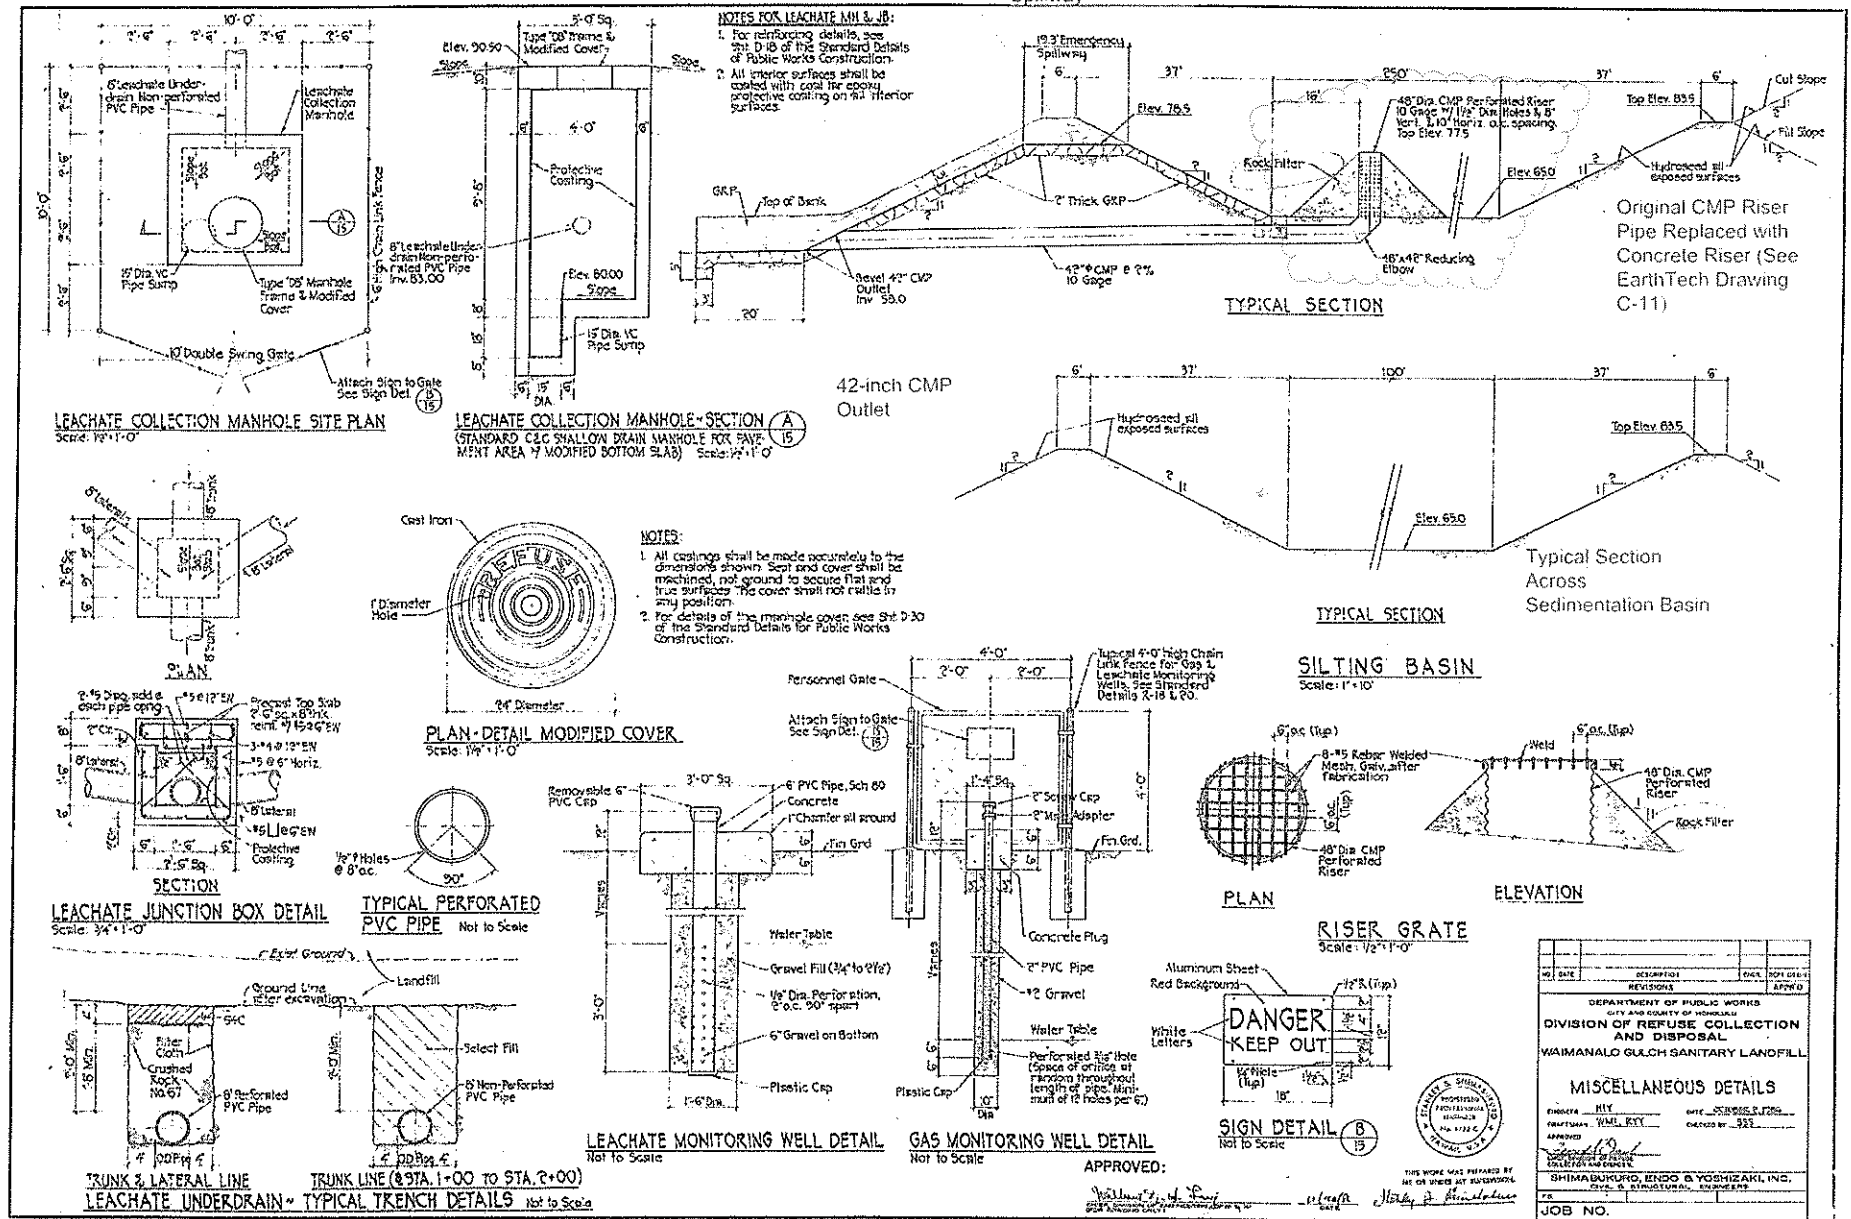
Riprapped
Embankment and
Spillway

- **Riprapped Embankment and Spillway** - An earthfill embankment was constructed at the south end of the basin to provide containment on the downstream side of the pond. The embankment is armored with a 2' thick layer of grouted riprap. The crest and downstream slope of the embankment functions as a spillway apron to discharge storm water downstream from the basin. The embankment was constructed with 2 H to 1 V sideslopes and a crest width of approximately 19 feet. The inboard sideslope of the embankment is

approximately 14 feet high. The outboard side of the embankment is approximately 21 feet high.

- **Riprapped Embankment and Spillway** - As a result of the December 2010-January 2011 storm events, sediment may have accumulated against the grouted riprap on the inboard and outboard faces of the embankment and spillway area. Any accumulated sediment in these areas will be removed and disposed properly in the landfill. Disposal may include using the material for daily cover. The overflow spillway will also be visually inspected for signs of debris that is blocking the overflow weir or that has migrated on the downstream face of the weir. All debris in the spillway will be collected and deposited in the landfill.

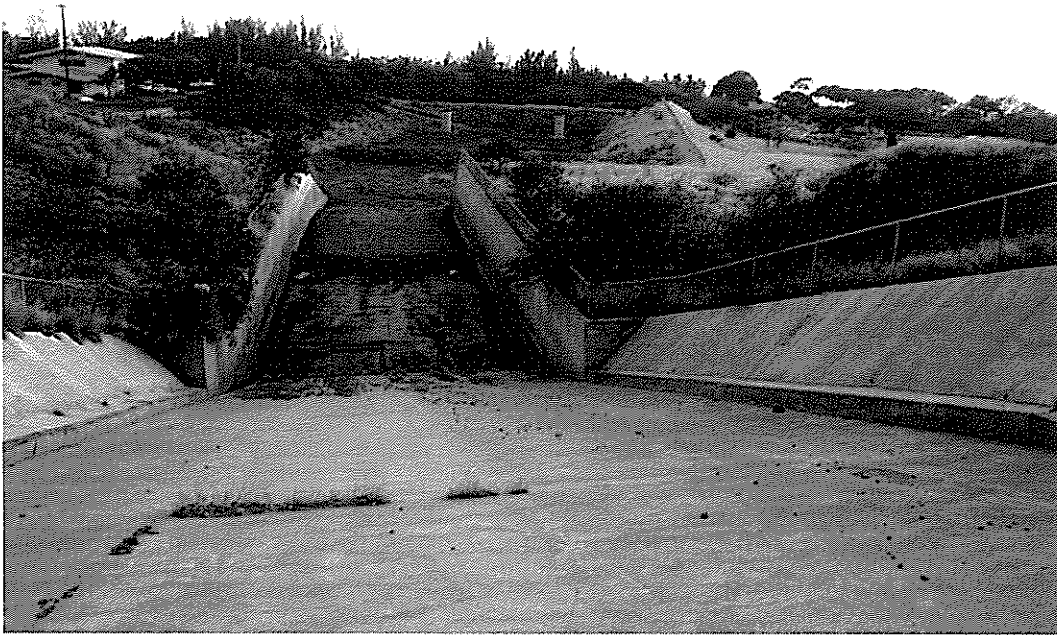
View of Basin Looking South Along the Western Concrete-Lined Drainage Channel

The sedimentation basin currently receives drainage that is collected in the western concrete-lined drainage channel immediately upstream of the basin. The sedimentation basin consists of the following elements, described in an upstream to downstream direction:

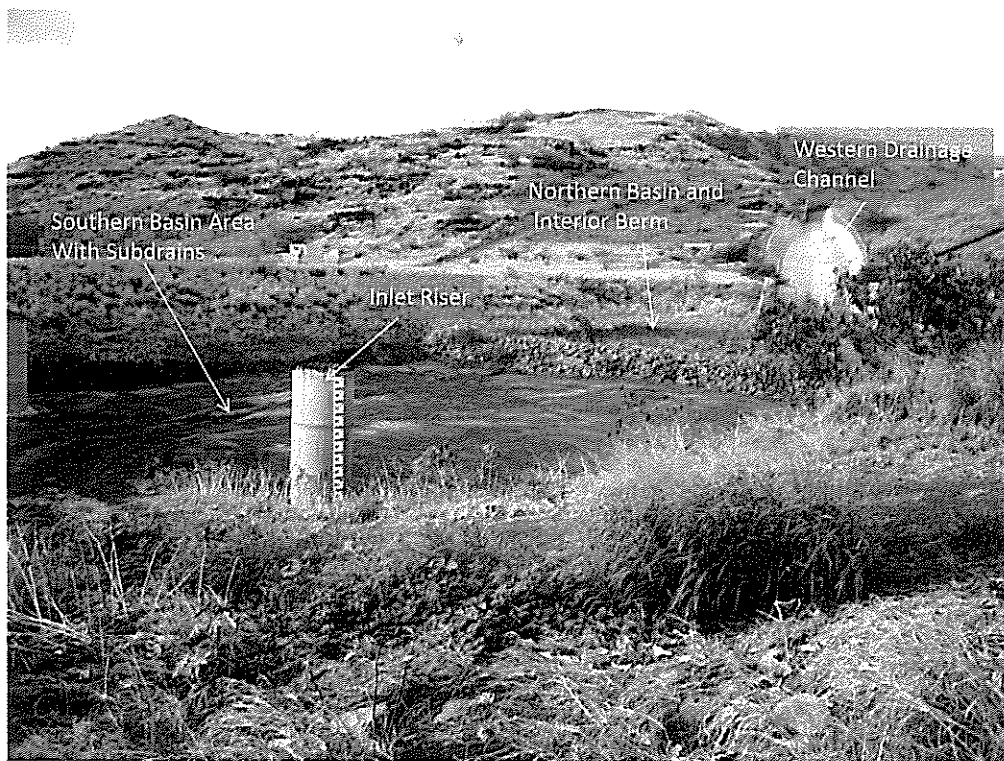
View of Sedimentation Basin Looking North

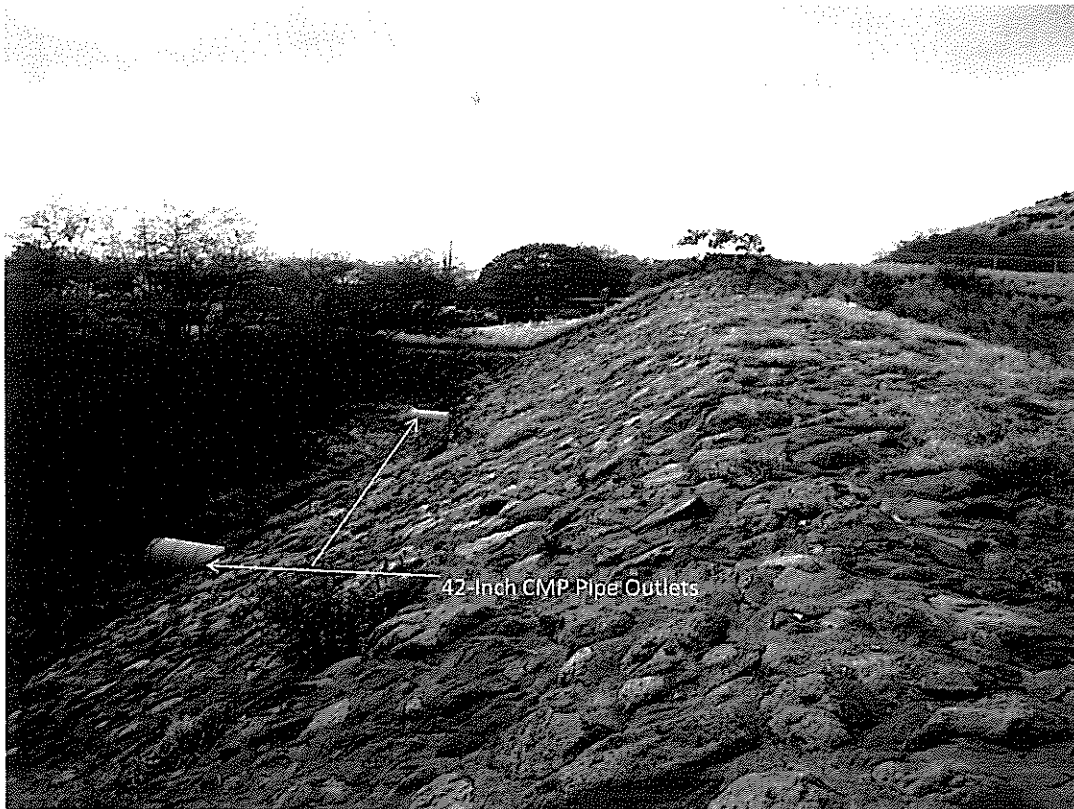
View along Riprapped Embankment Crest Looking West

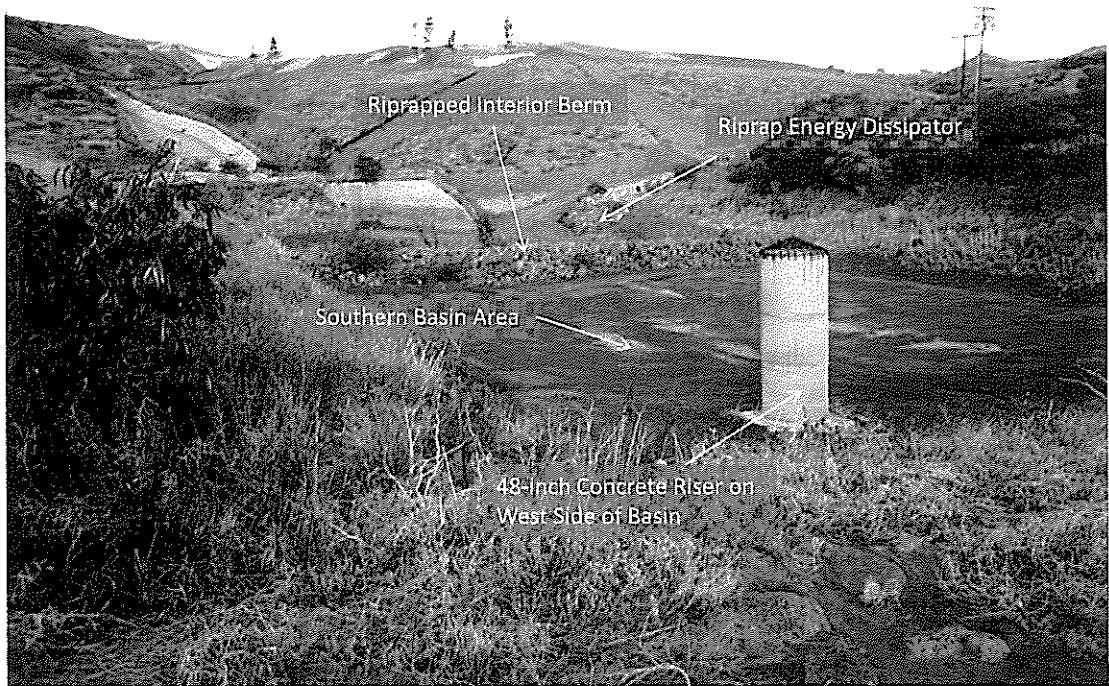
View of Basin Looking Northeast from Riprapped Embankment Crest
